National Park Service Jefferson National Expansion Memorial Gateway Arch

St. Louis, Missouri

Historic Structure Report – Volume 1

June 2010

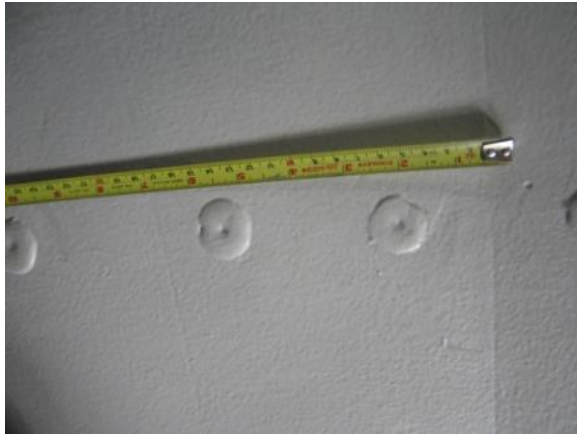
Figure 148. View of plug welds between Stations 0 and 28. Source: WJE, 2008.

From Station 0 to Station 28, the interior 1/4 thick stiffener plates, diaphragms, and 1/2 inch diameter diagonal bars are plug welded to the interior skin plate with 3/4 inch plug welds spaced at approximately 6 inches on center (Figures 147 and 148). The thicker interior skin corner plates (1-3/4 inch thick) are bolted to the interior stiffener plates with 1/2 diameter high strength bolts. The exterior skin plates are fastened to the internal stiffener plates and diaphragms with double spot fillet welds, spaced at a maximum of 5 inches on center. Transverse plates approximately 3/8 inches thick are welded to the inside face of the exterior plate and a closure plate at the interior skin, at each station line.

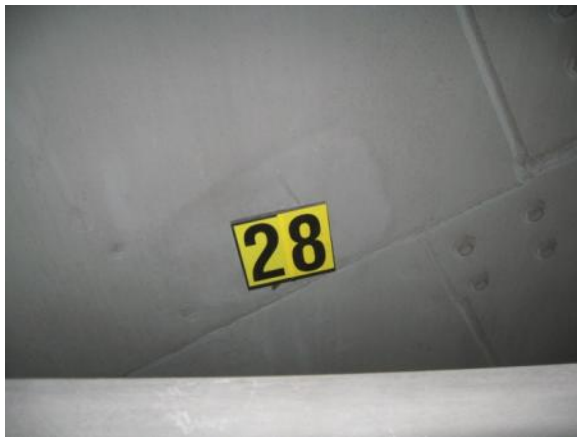
Figure 149. View of vertical shop welds at Station 28. Source: WJE, 2008.

The shop welds have been ground flush in some locations and appear to be single pass full penetration groove welds. The shop welds are typically the vertical welds between the plates that make up one Arch segment (Figures 149 and 150).

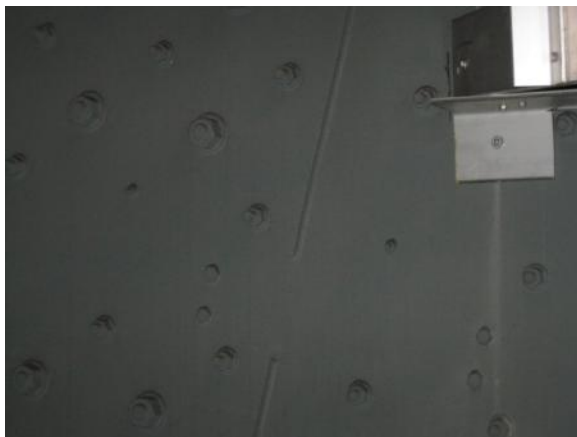
Figure 150. View of vertical shop weld, with portions ground flush. Source: WJE, 2008.

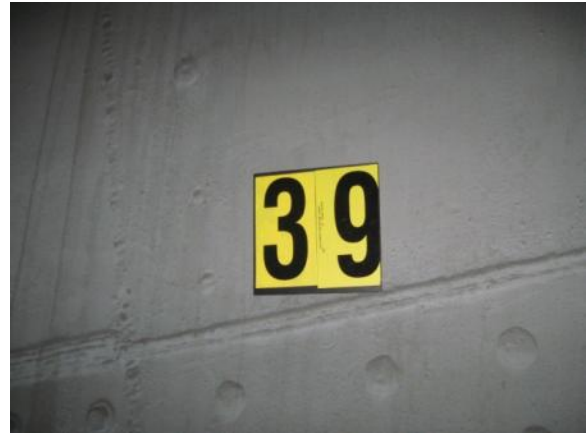
The field welds, visible on the interior, exist between segments and are multi-pass full penetration groove welds. The weld reinforcement above the plane of the plate is not flush with the plate surface. The multi-pass welds vary in size, which may have been necessary to accommodate for tolerance variances (Figures 151 through 153).

Figure 151. View of variable field welds between Stations 39 and 40. Source: WJE, 2008.

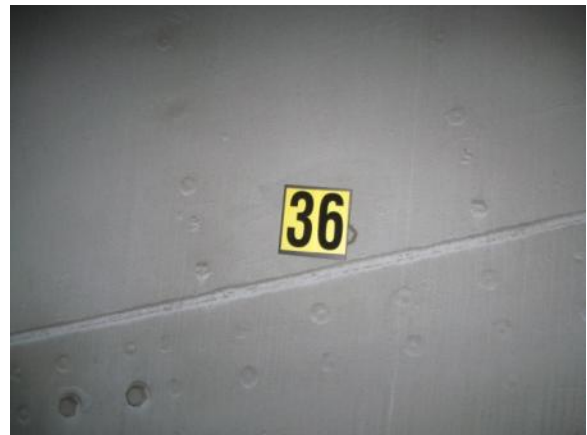
Figure 152. View of variable field welds between Stations 36 and 37. Source: WJE, 2008.

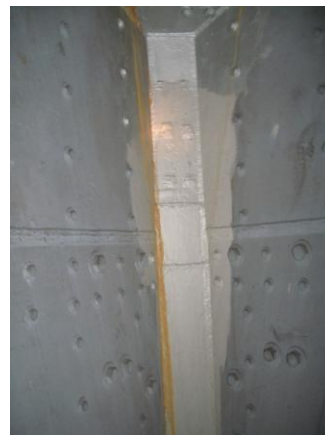
Figure 153. View of variable field welds between segments at extrados corner. Source: WJE, 2008.

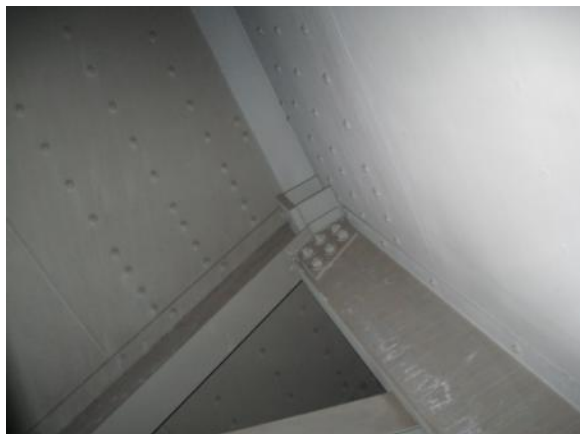
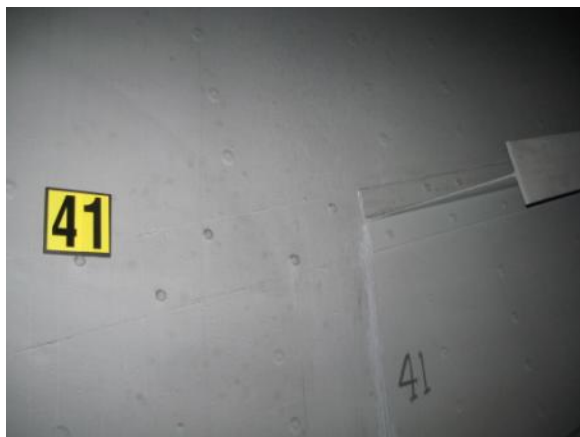
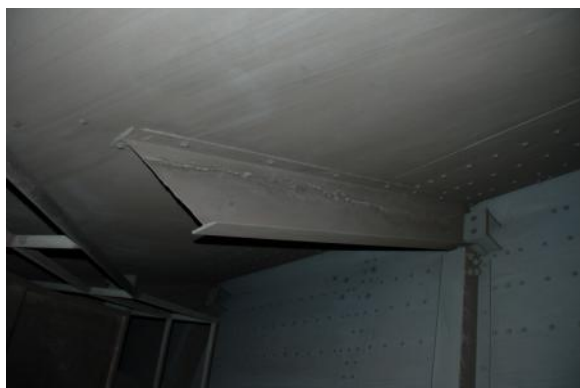
Portions of the steel framing used during erection remain in place, as evidenced by the I-beams whose flanges are bolted to the interior plates at approximately quarter spans of the height of each segment. The steel left in place was notched/torched in many locations to accommodate the tram system and stair components, thus is thought to have been used only for stiffening purposes during erection and construction. Figures 154 through 156 show typical locations of the erection framing on the interior of the Arch.

Figure 154. View of remaining erection wide flange framing at interior skin plates. Source: WJE, 2008.

Figure 155. View of remaining erection wide flange framing at interior skin plates. Source: WJE, 2008.

Figure 156. View of remaining erection framing at interior skin plates. Source: WJE, 2008.

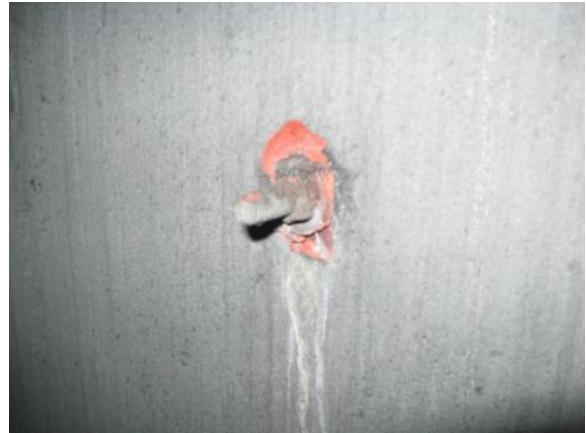
Moisture staining, as evidenced by numerous streaks and some white residue, was observed. The white residue is present at random bolt heads/nuts. This condition was more prevalent at the small 3/8 diameter stud bolts below Station 45, which tie the interior and exterior plates together (Figures 159 and 160).

Figure 159. View of moisture staining at bolt heads. Source: WJE, 2008.

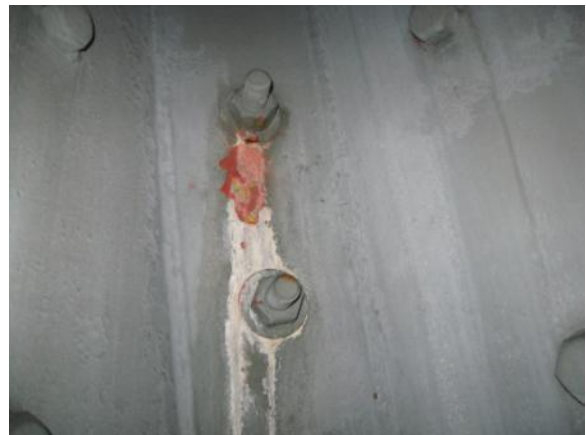
Figure 160. Typical view of moisture staining at bolted connections. Source: WJE, 2008.

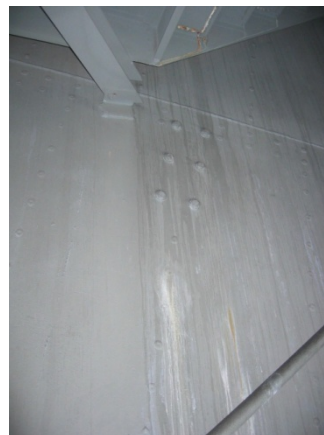
Streaks were visible on many of the painted steel plates inside both legs of the Arch, suggesting significant condensation formation that could form water droplets and create streaking marks. See Figures 161 through 163 for typical water marks and streaking observed on the interior carbon steel plates.

Figure 161. View inside north leg of deposits/staining from water on the interior surface of the structure. Source: WJE, 2008.

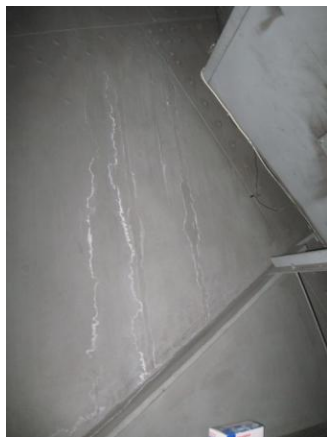
Figure 162. View of streaks visible on many of the interior painted steel plates. Source: WJE, 2008.

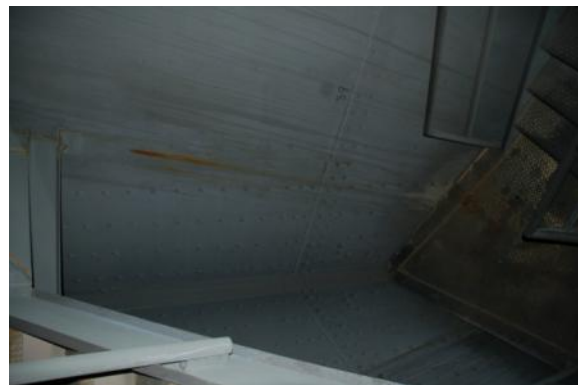
In the south leg, streaking and evidence of moisture condensation is more consistently present (Figures 164 through 166).

Figure 165. View of streaks visible on many of the interior painted steel plates in the south leg. Source: WJE, 2008.

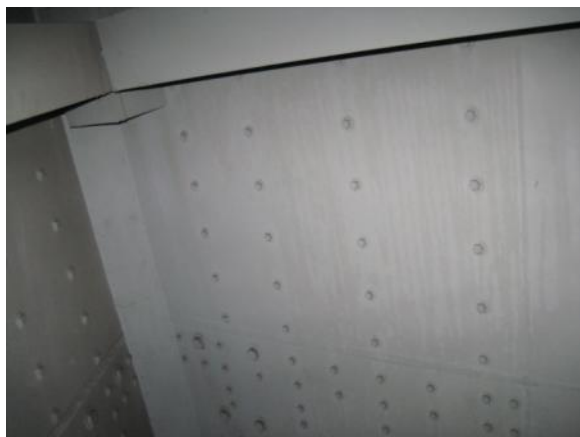
Figure 163. View of minor streaks visible on many of the interior painted steel plates. Source: WJE, 2008.

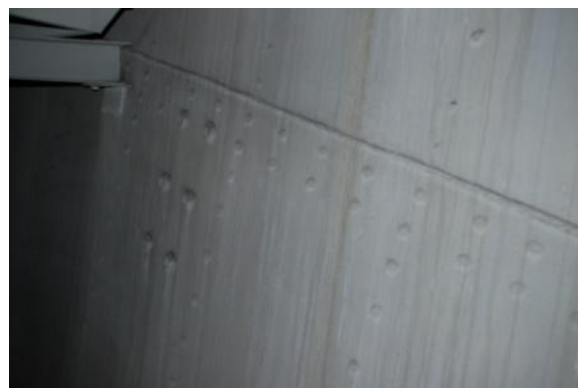
Figure 166. View of streaks visible on many of the interior painted steel plates in the south leg. Source: WJE, 2008.

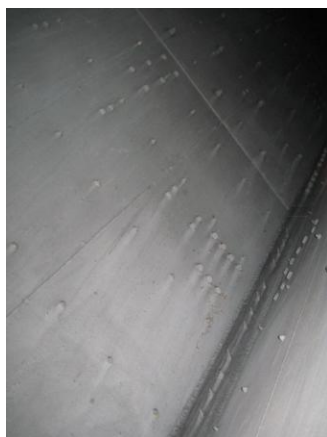
Figure 164. View of streaks visible on many of the interior painted steel plates in the south leg. Source: WJE, 2008.

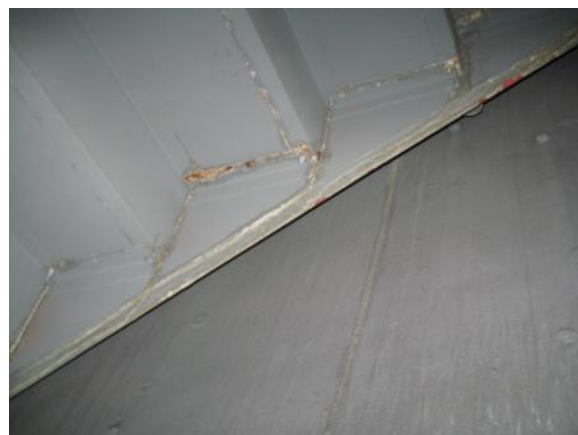
Streaking, evidence of previous standing water, and surface corrosion were apparent on the horizontal stair surfaces of the stair landings and treads, and any horizontal surfaces where moisture can accumulate. Evidence of moisture on the stair treads/landings appears to be more significant at the south leg. Figure 167 shows an example typical corrosion at painted steel stair treads and landings.

Figure 167. View of evidence of standing water, as indicated by surface corrosion at underside of stairs. Source: WJE, 2008.

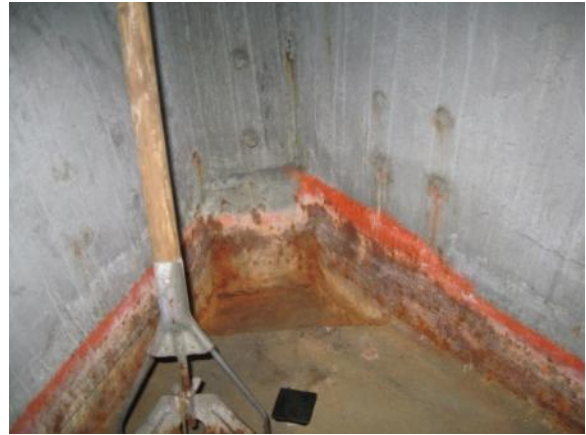
At the bottom of the north base Segment 71, the top of the concrete foundation, corrosion was found at intrados corners where water may have collected for prolonged periods. See Figures 169 and 170 for examples of corrosion occurring at the base segment in the north leg due to pooling water. The corrosion of the south leg at the base segment is not as severe as that of the north leg. A view of the corrosion of the south leg shown in Figure 171.

Figure 169. View of corrosion occurring at the base segment in the north leg. Source: WJE, 2008.

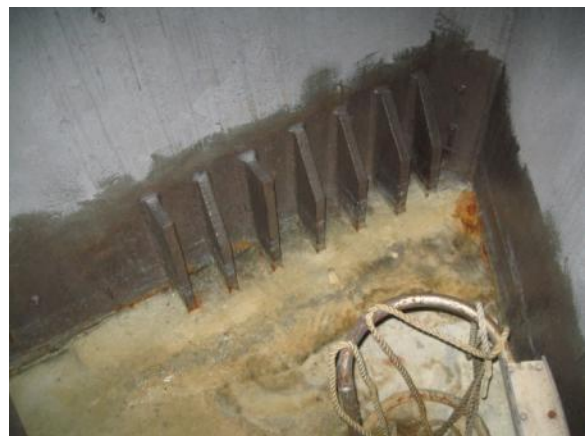
Figure 171. View of corrosion of the south leg at the base segment is not as severe as at the north leg. Source: WJE, 2008.

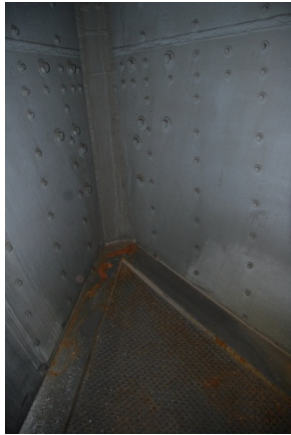
Figure 172. Surface corrosion on the horizontal surface of the temporary erection framing and stair landings. Source: WJE, 2008.

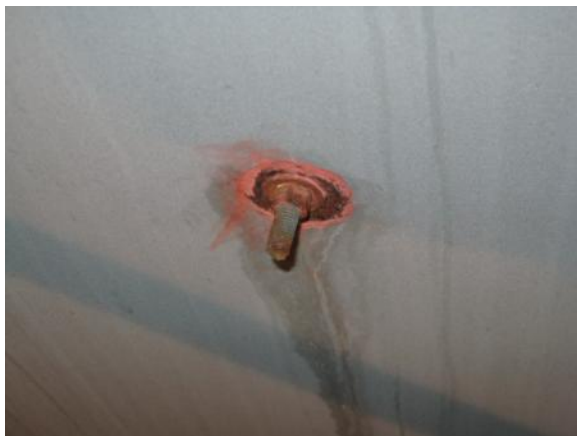
Isolated surface corrosion exists at a number of locations on the interior skin plates, both above and below the termination level of the concrete fill. The corrosion has typically initiated at bolt heads/fasteners in the carbon steel plate or at joints within the stairs where water can collect and the paint coating is more likely to have defects (Figure 172). Typically, many of the shanks of the small 3/8 inch diameter stud bolts were observed to be more severely corroded than the heads of the high strength bolts (Figures 173 through 175).

Figure 173. Many of the shanks of the small diameter stud bolts were corroding more severely than the heads of the high strength bolts. Source: WJE, 2008.

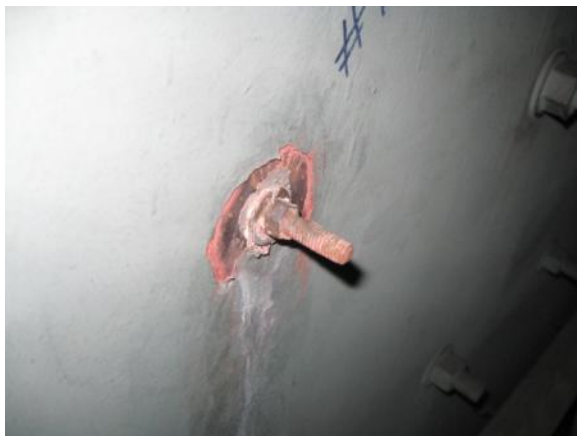
At Segment 45, which marks the top of the concrete pour, some of the bolts, washers, and nuts are corroding, indicating that there may be moisture trapped in the interstitial space between the two skin plates. It was also observed that many of the corroded bolts had been circled and numbered, indicating that they were the focus of previous surveys, though according to JNEM personnel there appears to be no record of any such survey.

Figure 174. View of corroding bolts at the concrete termination, Station 45. Source: WJE, 2008.

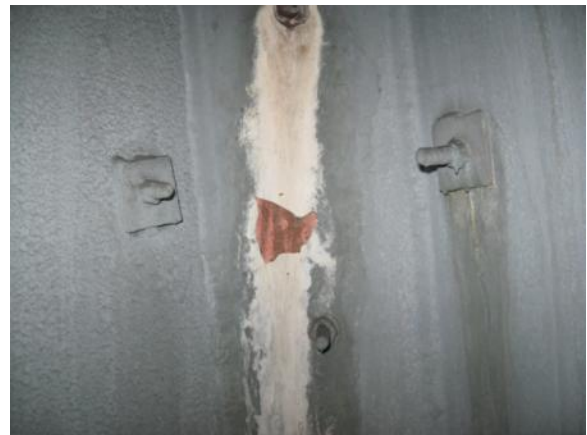
At locations where surface corrosion exists on the interior plates, only minimal section loss was observed on the interior skin. The actual amount of section loss could not be confirmed during this study because both sides of the interior steel plates are not visible (Figure 176).

Figure 176. Example of limited surface corrosion observed on interior carbon steel plates. Source: WJE, 2008.

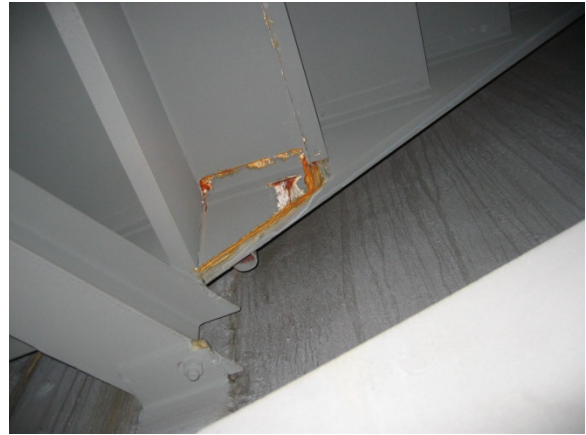
Surface corrosion was apparent on stair landings and treads where water would naturally collect (Figure 177 and 178).

Figure 177. View inside south leg of corrosion along underside of stair treads. Source: WJE, 2008.

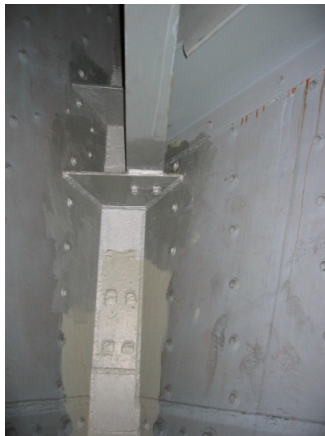
Inside the Arch, the carbon steel is typically covered by a grey paint coating. The coating is typically in good condition; however, some coating distress has occurred, including significant delamination and repainting in areas of previous paint loss showing area that was likely repainted due to distress in the paint coating on the steel (Figure 179).

Figure 179. View inside south leg of repainted area on carbon steel. Failure of the original paint layer in this area may have been due to rusting of the steel. Source: WJE, 2008.

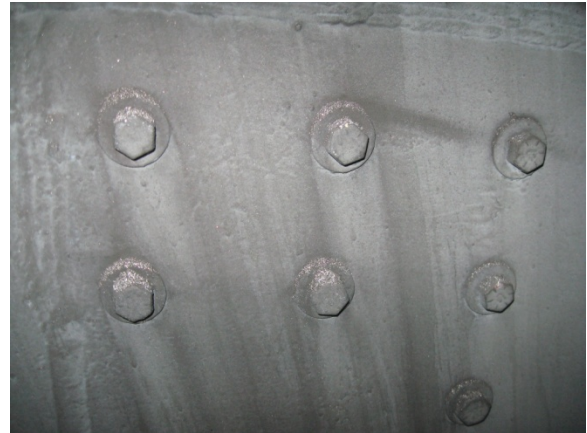
Inside the Arch, the carbon steel plates are generally coated with a grey paint and primer. Refer to Appendix B for a more detailed description of the coatings. Graphite shavings cover much of the horizontal surfaces on the interior of the Arch legs (Figure 180); these deposits are a byproduct of the sliding carbon shoes used to maintain electrical and signal continuity with the moving tram and/or the motor brushes of the direct current generators. JNEM maintenance staff indicated that a large central vacuum system is used to clean the interior legs of the Arch on a biannual basis (Figures 181 and 182).

Figure 180. View of graphite shavings remaining on the bolt heads. Source: WJE, 2008.

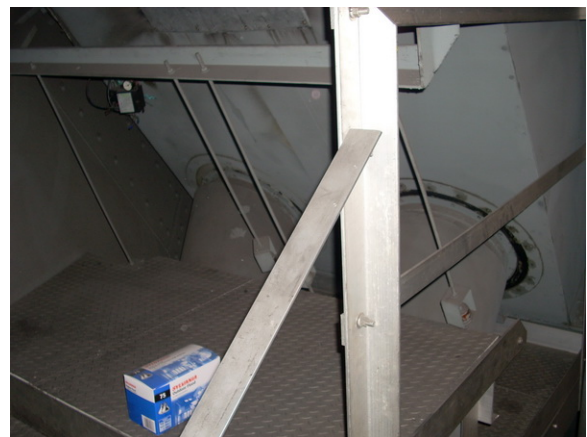
The existing mixing boxes serving the Arch legs are large dual duct boxes with internal hot and cold plenums and mixing chambers (Figure 187). These mixing boxes are original to the construction of the Arch and its associated mechanical systems. Each mixing box connects to both the hot and cold high pressure supply air ductwork, and modulates the ratio of hot-to-cold airflow through the box in order to maintain a set point temperature.

Figure 187. Arch leg mixing box hot and cold duct connections. Source: Alvine, 2008.

The dual duct mixing boxes serving the Arch legs appear to be in fair condition, due to the age and unknown internal condition of the mixing boxes. No operational deficiencies were observed or reported by park maintenance staff.

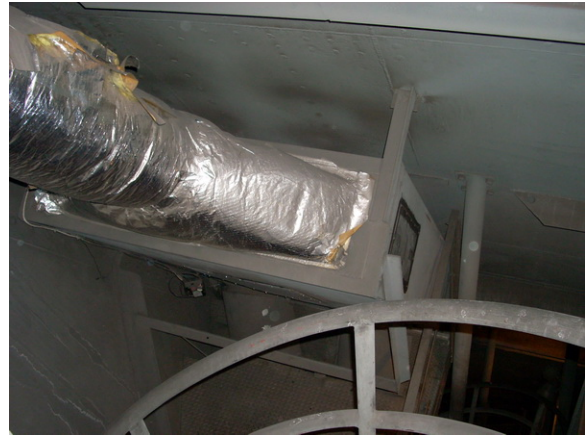
Figure 188. Observation deck mixing box and duct connection. Source: Alvine, 2008.

The existing mixing boxes serving the north and south observation level do not have outlets located on the various sides of the mixing box enclosure. Instead, these boxes have a duct connection at the top side of the box, to which the ductwork serving the observation level is connected (Figure 188). According to archival shop drawing information, the existing mixing boxes serving the north and south observation level and upper tram load zones each have 2,500 cfm airflow capacity.

The observation level mixing boxes appear to be in fair condition, due to age and unknown internal condition. No operational deficiencies with the boxes were reported by park maintenance staff.

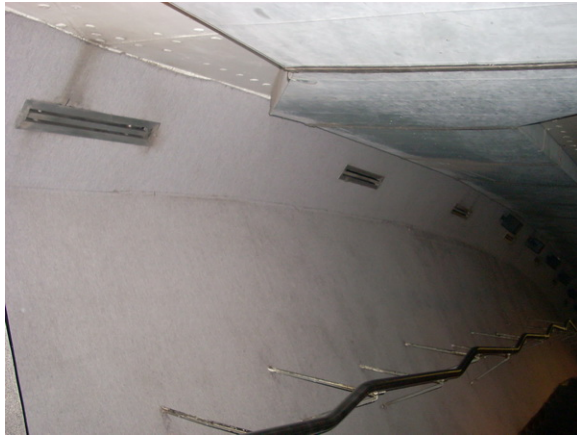
*Figure 191. Upper tram load zone air distribution.
Source: Alvine, 2008.*

The upper tram load zones just below the observation level are served by existing linear slot diffusers in the walls opposite the tram doors. There are a total of nine diffusers in the wall of each tram load zone, and each diffuser is approximately 24 inches wide by 4 inches tall. The ductwork serving these existing diffusers is located behind the wall of the tram load zone (Figure 191).

The ductwork serving the observation level and upper tram load zones is in fair condition. The external insulation on the 20 inch round supply duct between the mixing box and upper tram load zone is torn in some locations. However no construction or operational deficiencies are apparent or were reported by park maintenance staff.

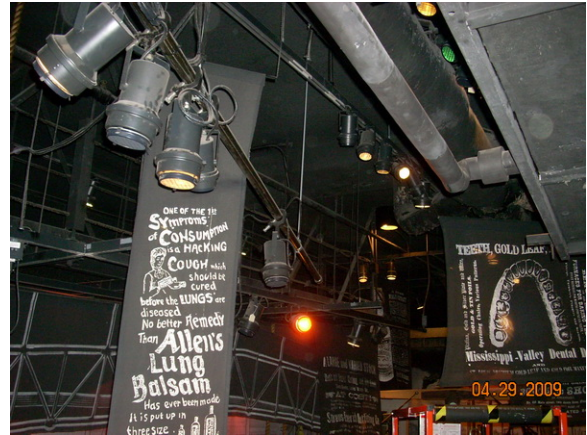
The existing air handlers serving both the north and south tram load zones appear to be in good condition. No operational deficiencies with the air handlers were reported by park maintenance staff. The associated condensing units could not be accessed or viewed during the investigation. The condition of these condensing units is assumed to be fair to good based on the age of the units, and no operational deficiencies were noted by park maintenance staff.

Figure 192. Lower tram load zone air handler and piping connection. Source: Alvine, 2008.

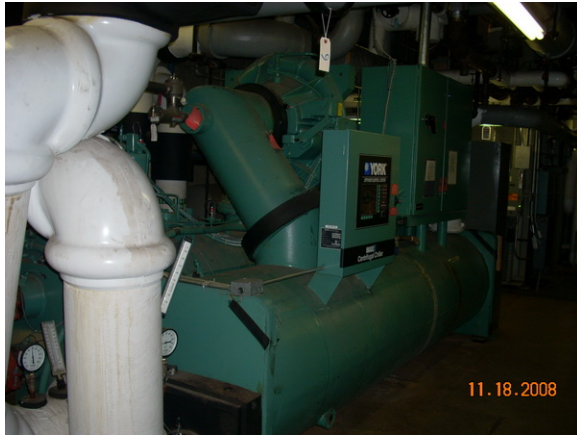
Figure 193. Existing 300 ton chiller. Source: Alvine, 2008.

The existing chillers are in good condition and have been well maintained by the park maintenance staff. No operational problems or deficiencies were observed or reported with the existing chillers.

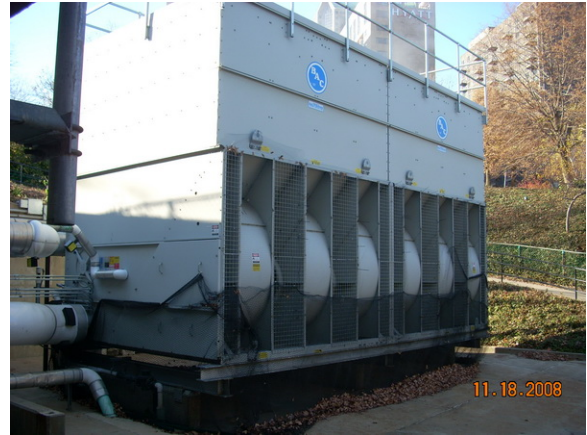
Figure 194. Baltimore Air Coil cooling tower. Source: Alvine, 2008.

The existing cooling tower is in good condition and is well maintained by park maintenance staff. No operational deficiencies

were observed or reported with the cooling tower.

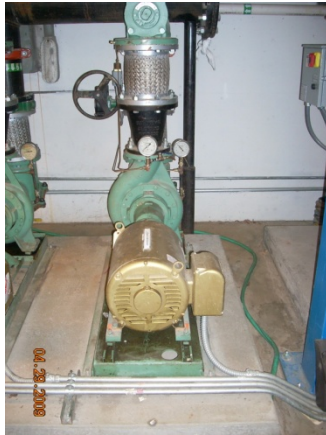
The existing chilled water pumps and pump motors are in good condition. It is unknown

Figure 195. Existing chilled water pump. Source: Alvine, 2008.

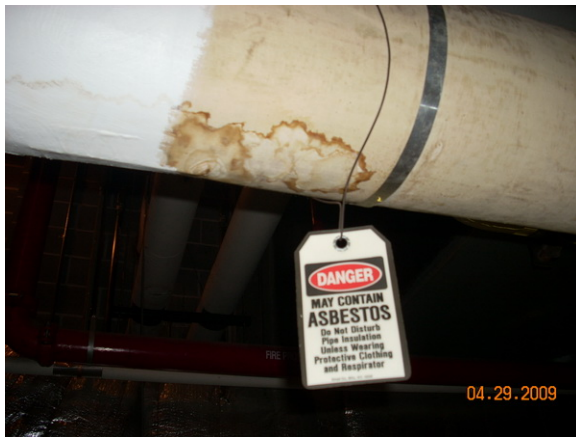
The existing chilled water piping system is in fair condition. No leaks or major operational deficiencies were observed or reported by park maintenance staff. However, portions of the existing chilled water piping system within the north mechanical room are missing insulation. The chilled water piping insulation that is present in the mechanical room appears to be a mix of old insulation and new insulation. Some of the existing chilled water piping insulation in the north mechanical room has been tagged as possibly containing asbestos (Figure 196). The chilled water piping insulation as a whole is in poor condition. The age of the piping system, unknown condition of the piping interior, condition of the piping insulation, and unknown history of water quality control contribute to the assessment of the piping. Some degree of internal piping deterioration or erosion may also be present.

Figure 196. Asbestos tag on existing chilled water piping. Source: Alvine, 2008.

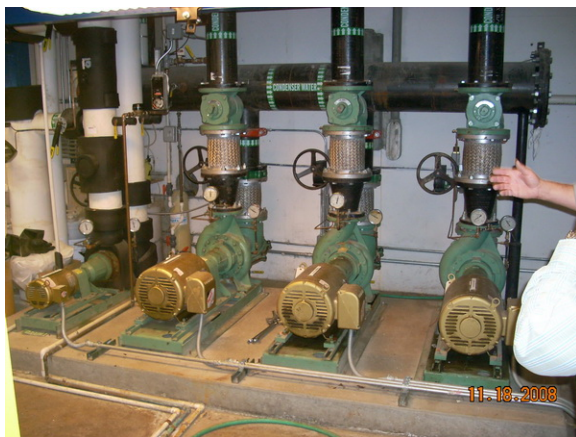
Figure 197. Condensing water pumps. Source: Alvine, 2008.

The existing condenser water pumps and pump motors are in good condition. According to park maintenance staff, the pumps do tend to cavitate slightly when the pump suction strainers become clogged with debris, which is typical for end suction pumps. It is unknown as to whether or not the existing pump motors are original to the pumps themselves, and no archival documentation has been found to confirm a timeframe for pump motor replacement.

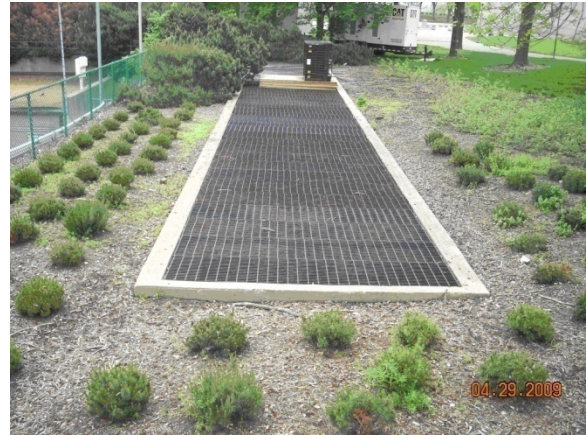
The primary electrical power distribution system, including the pad-mount transformers, is owned and maintained by the local power company, AmerenUE. The pad-mount transformers are located in an open-top with grate in-ground transformer vault (Figure 198). The primary power distribution system is in good condition. There are three electrical kilo-watt-hour meters labeled “Arch Main,” “Bi-State Main,” and “Site Lighting” (Figures 199 and 200).

Figure 198. The pad-mount transformers are located in an open-top with grate in-ground transformer vault. Source: Alvine, 2008.

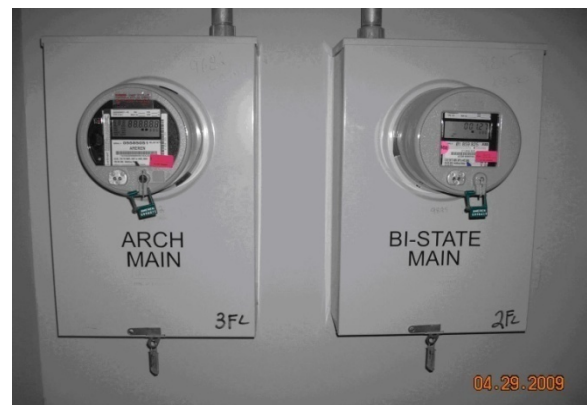
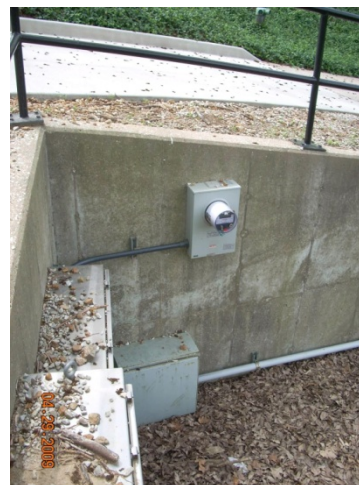
Figure 199. Two of the meters, labeled “Arch Main” and “Bi-State Main.” Source: Alvine, 2008.

Figure 200. The third meter, labeled “Site Lighting.” Source: Alvine, 2008.

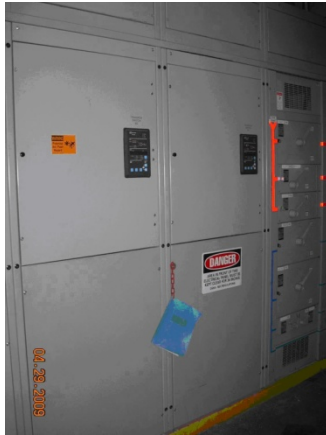
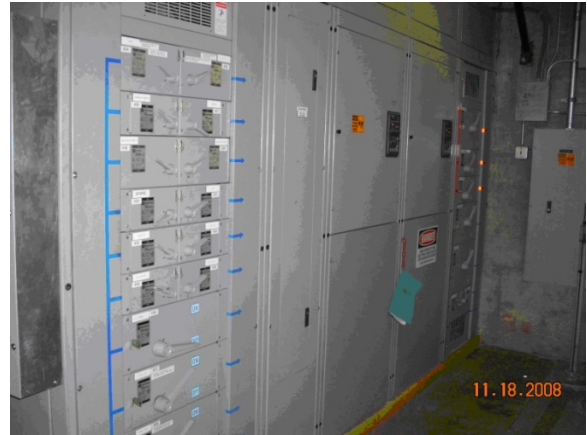
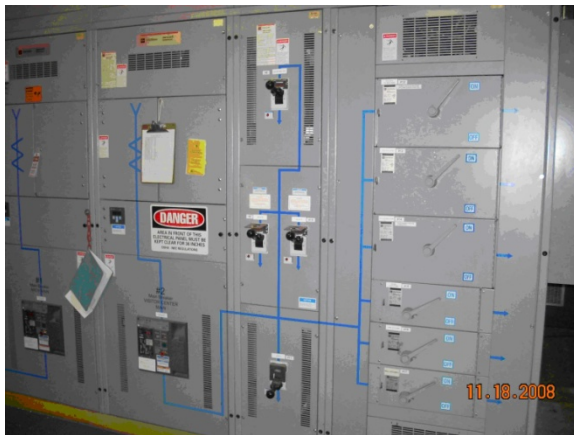
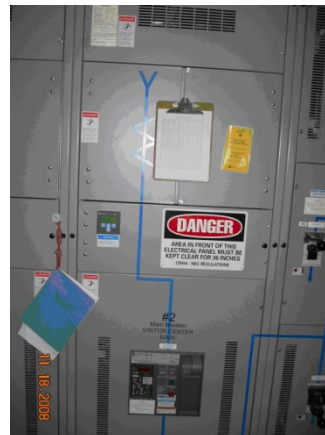
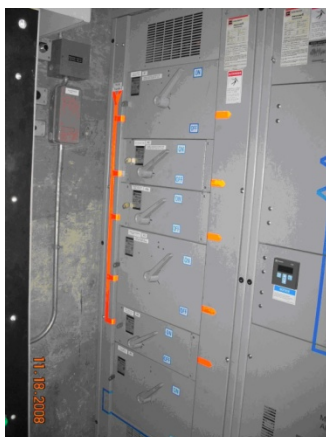
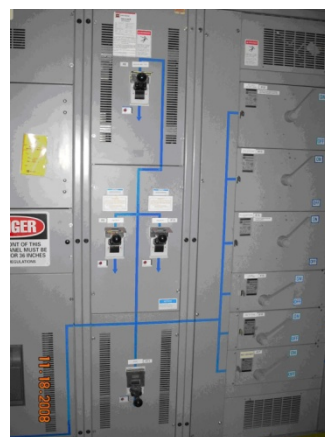
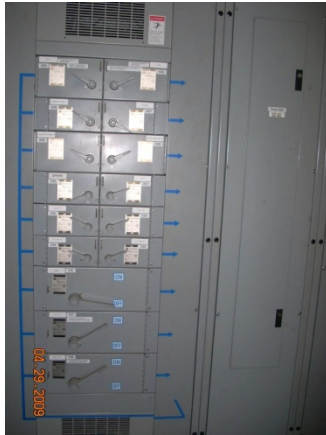
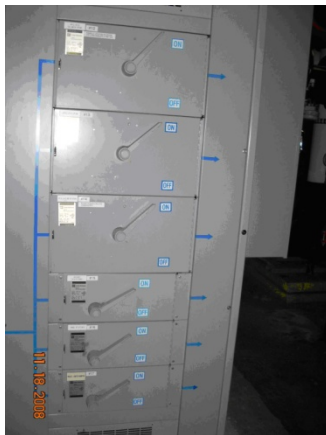
The building has a Culter Hammer Power line “C” 480Y/277-volt, three phase, four wire switchboard with two 2,000 amp main breakers and two split buses connected via automatic transfer switches (Figure 201) to the emergency distribution system (Figure 202 through 204).

The switchboard has mimic bussing on the face of the switchboard (Figure 205). Each of the two 2,000 amp main breakers is connected to a power company pad-mount transformer via a 2,000 amp electrical feeder. The overcurrent protective devices in the switchboard are fusible switches (Figure 206 and 207) and circuit breakers (Figure 208). The switchboard has a split bus, which separates normal and emergency power. The switchboard was installed in December 1998 after an electrical fire destroyed the original switchboard. There is a separate outside electrical service for site lighting.

The electrical service system is in good condition.

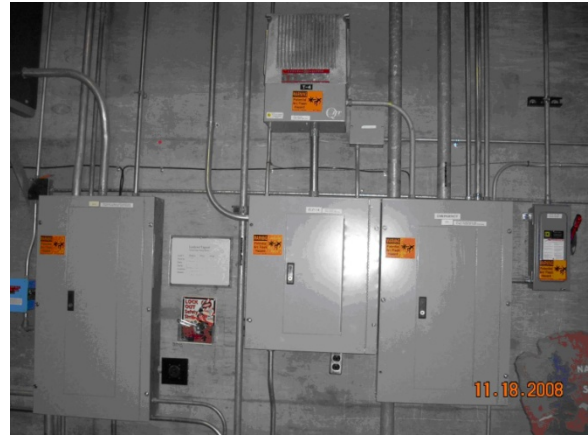
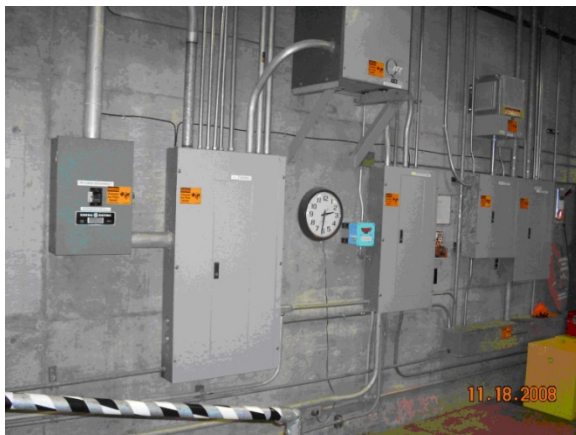
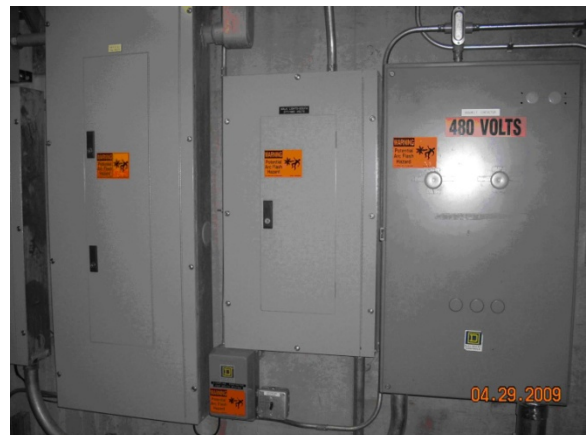
Distribution of electrical power downstream of the electrical service switchboard consists of panelboards with circuit breaker overcurrent devices (Figure 209). Dry type transformers are used to transform the voltage from 480 volts to 208Y/120 volts (Figure 210). In the Arch legs there are several specially made combination 480-208Y/120 volt transformers with 208Y/120 volt panelboards. The transformer is wedge shaped to fit in the corner of the Arch legs. The downstream distribution system is in good condition.

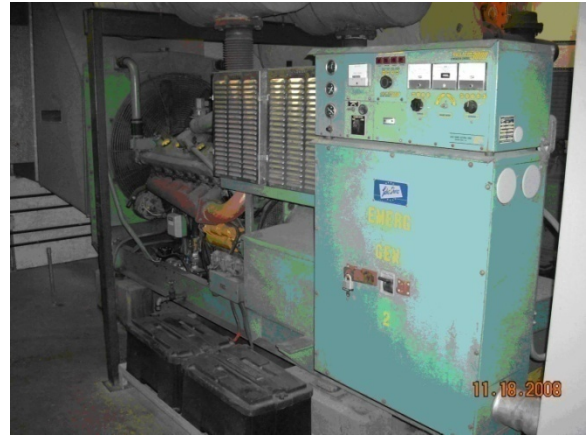
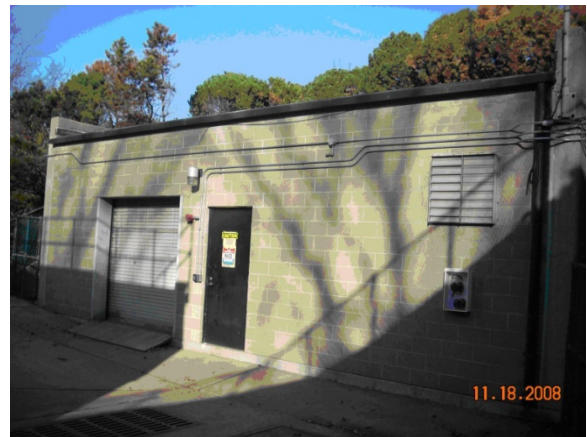
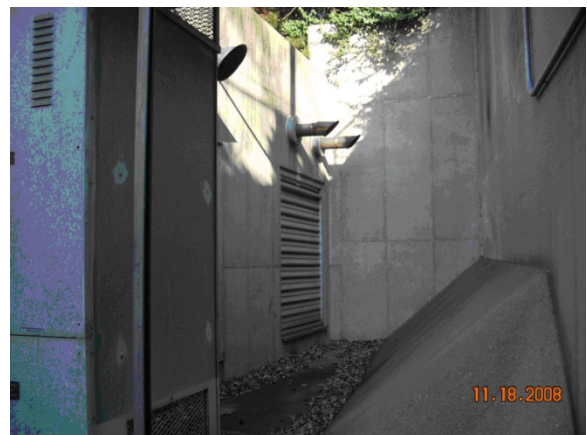
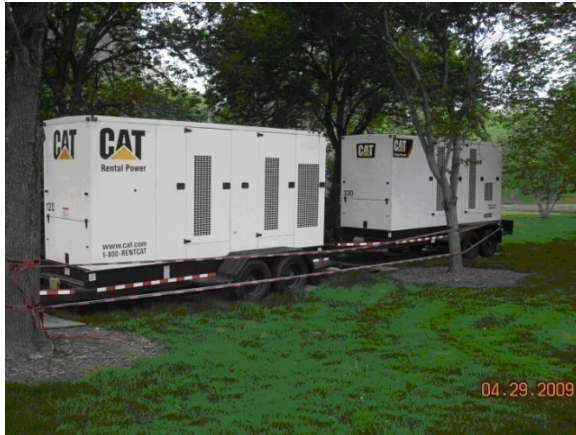
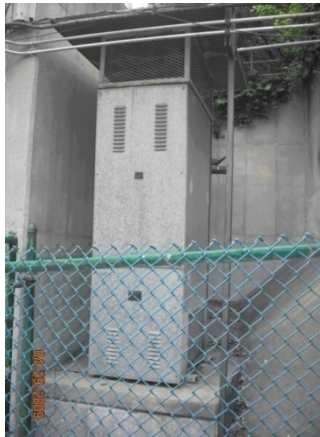
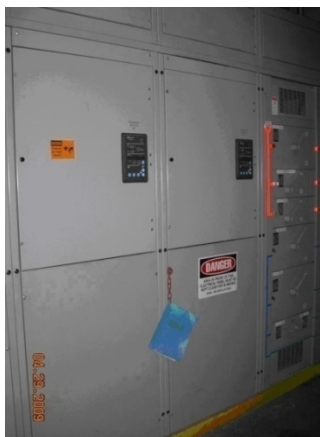
In 2009 the original 235 KW and 300 KW diesel powered emergency generators (Figure 213) were replaced by two new 350 KW diesel powered emergency generators.

During the transitional period between removing the two original emergency generators and installing the two new emergency mounted generators were on site with temporary power connections back to the emergency power distribution system (Figure 214).

The two 350 KW emergency generators are located in a separate building (Figures 215 through 217).

There are two automatic transfer switches in the main 480Y/277 volt, 2,000 amp switchgear in the mechanical room. There is an outside load bank with three stages of resistance: 120 KW, 180 KW, and 240 KW (Figure 218).

The two new 350 KW generators and the emergency power distribution system are in good condition.

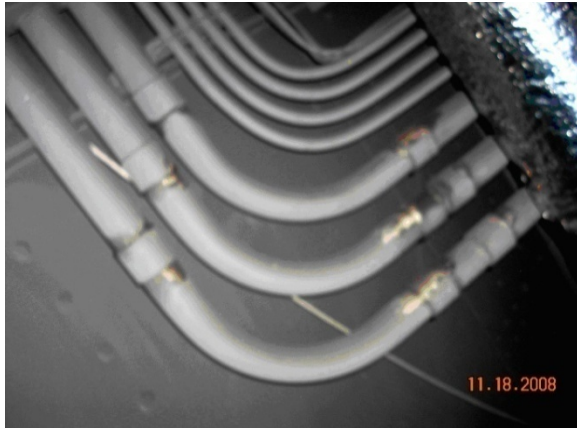
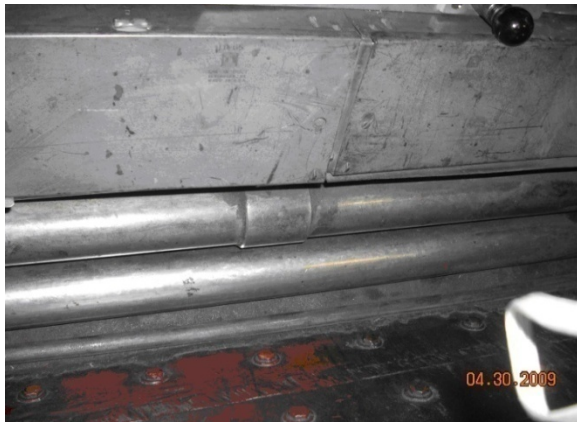
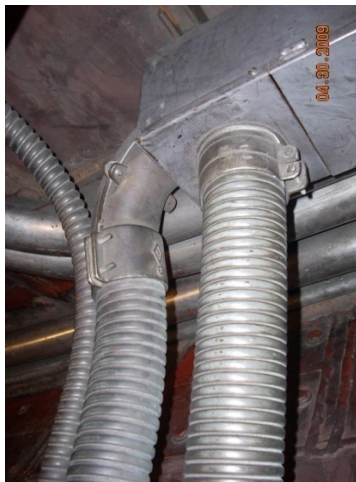
The electrical wiring in the Arch proper consists of conductors installed in threaded steel conduit (Figure 219 and 220). Electrical wiring in mechanical rooms consists of conductors installed in electrical metallic tubing (EMT). The EMT conduits have a mixture of set screw fittings and compression fittings. Flexible steel conduit is used in tight bend areas (Figure 221). The routing of the conduits in the Arch legs is in the corner of the legs. Special triangular shaped pull-boxes are used. The copper wire insulation used during the original construction period was probably type THW or TW. The tram load zones, which were remodeled in 1998, probably have copper wire conductors with THHN/THWN insulation. The original interior wiring is in fair condition due to its age. The 1998 wiring is in good condition.

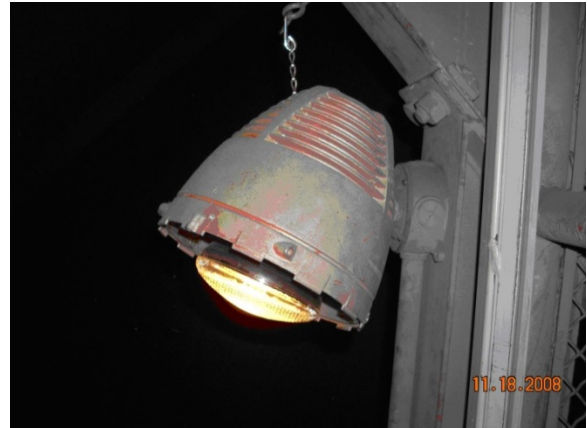
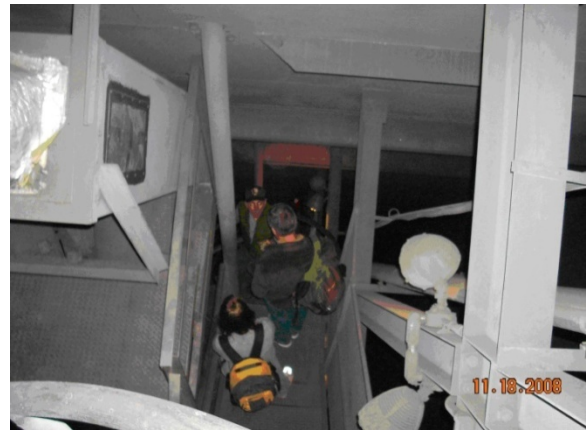
The legs of the Arch proper along the stairs have a mixture of incandescent “fruit jar” type lighting fixtures (Figures 222 and 223) and recently added halogen flood lighting fixtures. Some of the halogen flood lighting fixtures have individual control switches. The lighting is connected to the emergency power distribution system. The lighting at the top of the Arch has wall-mounted or under-railing fluorescent lighting fixtures (Figures 224 through 226). The lighting fixtures in the tram equipment area below the observation deck are a strip fluorescent (Figure 227). The tram load zones, which were remodeled in 1998, have incandescent downlights with self ballasted fluorescent lamps, wall washer lighting fixtures with T-5 fluorescent lamps, track mounted lighting fixtures with incandescent PAR lamps, and track mounted lighting fixtures with halogen lamps (Figures 228 through 230). There is an aircraft warning light located on the top of the Arch. The lighting system is in fair condition.

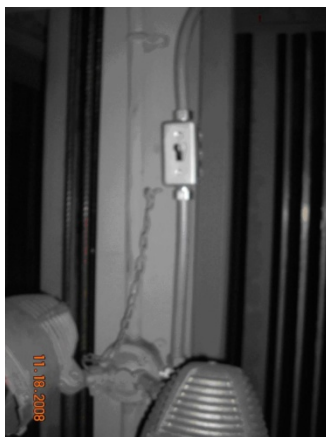
Figure 232. Convenience 120-volt, 15-amp receptacle along stairwell in Arch leg. Source: Alvine, 2008.

In the Arch legs there are 120 volt, 15 amp, grounded ivory colored receptacles mounted along the side of the stairwells (Figure 232). Switches alongside the stairwells control individual halogen floodlights (Figure 233). There are 120 volt, 15 amp, grounded convenience receptacles on the observation level and at the tram load zones. The devices are in fair condition due to age and accumulation of oily graphite.

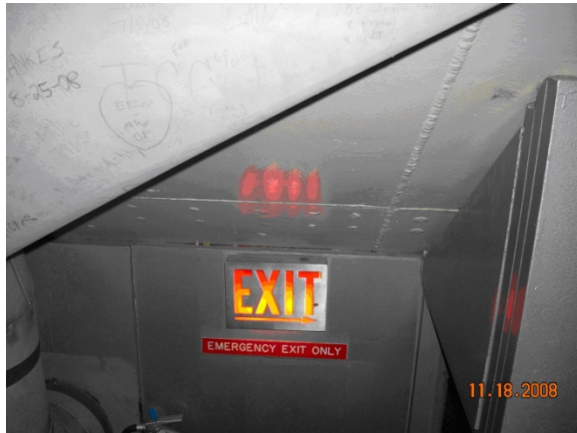
The original exit lighting fixtures have red letters and are illuminated with incandescent lamps (Figure 234). The tram load zones have exit lighting fixtures with light-emitting diode (LED) or fluorescent lamps (Figure 235). The exit lighting fixtures are located in the lower tram load zones, upper tram load zones, at the top of the Arch in the visitor observation area, and back of house in the corridors. The original exit lights are in fair condition, as they do not use highly energy efficient lamps. The tram load zone exit lighting fixtures are in good condition.

Figure 234. Exit lighting fixture at observation deck level. Source: Alvine, 2008.

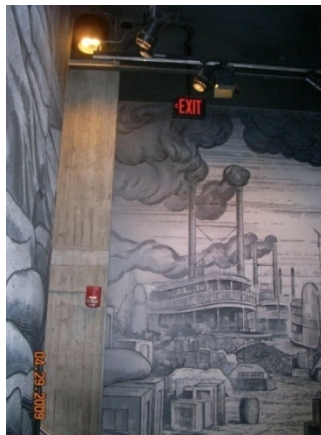
Figure 235. Exit light and fire alarm/horn strobe light in tram load zone. Source: Alvine, 2008.

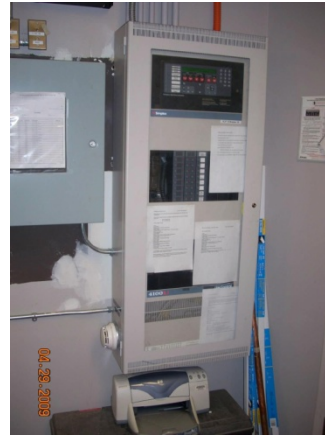
There are three node panels: one in the maintenance office, one in the south leg, and one in the courthouse. The fire alarm system is in good condition. The fire alarm system includes the following Simplex fire alarm equipment and catalog numbers:

Figure 239. Main fire alarm control panel. Source: Alvine, 2008.

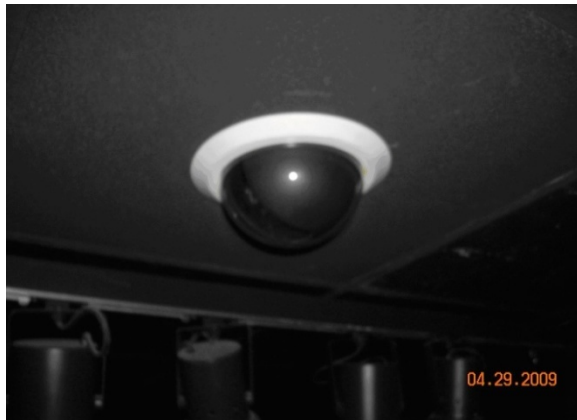
The Arch entrance has intrusion alarm motion detectors (Figure 242). There are no intrusion detection alarm devices in the Arch legs, tram load zones, or observation level area. Access doors have card access key pads. The intrusion alarm system is in good condition.

Figure 242. Security camera. Source: Alvine, 2008.

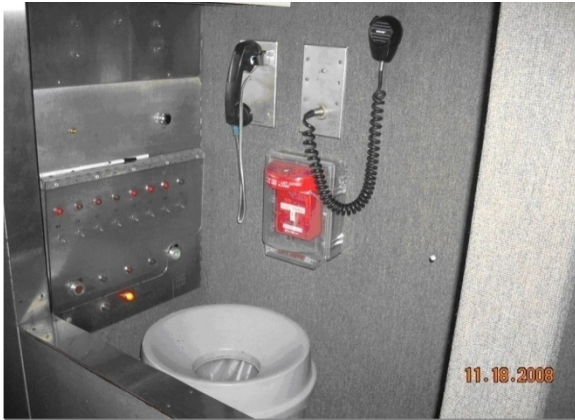
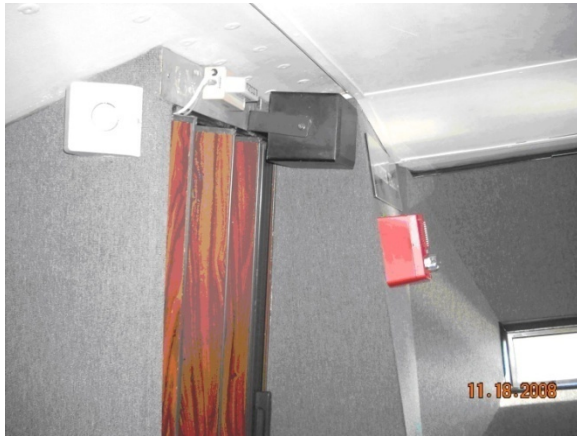
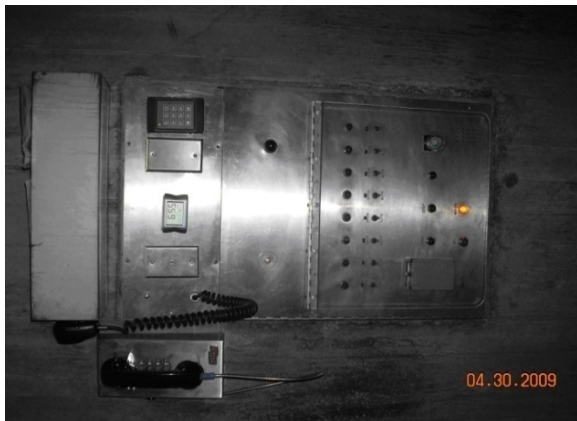
At the top of the Arch in the visitor observation area, there are telephone and communication speakers (Figures 243 through 245). The paging system is through the fire alarm speakers. The paging zones are the lobby, tram load zones, and museum. The communication system is judged to be in fair condition due to the lack of speakers in the Arch legs.

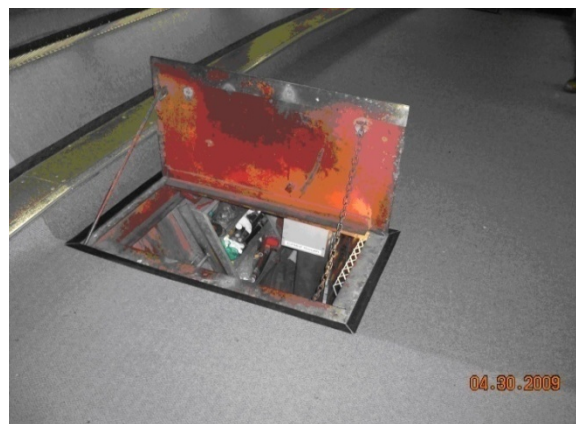
Figure 251. Access door to subfloor area below visitor platform. Source: Alvine, 2008.

The tram equipment controllers are located at the top of the Arch visitor viewing area below the floor, with access through floor hatches (Figure 251). There are two, 125 horsepower, 75 KW motor generator sets and two, 125 horsepower traction hoists at the top of the Arch visitor viewing area below the floor. The area below the floor at the top of the Arch has four 200 amp three pole disconnect switches and four 30 amp three pole disconnect switches that serve motor generator sets and tram controllers. There are 480-240 volt, three phase transformers in the area below the floor at the top of the Arch, which power the trolley bus bars. The electrical feeders and branch circuits in this area are installed in rigid galvanized steel conduits. The electrical connections to the tram equipment are judged to be in fair condition due to age and working space that is insufficient to comply with current codes (Figures 252 through 254).

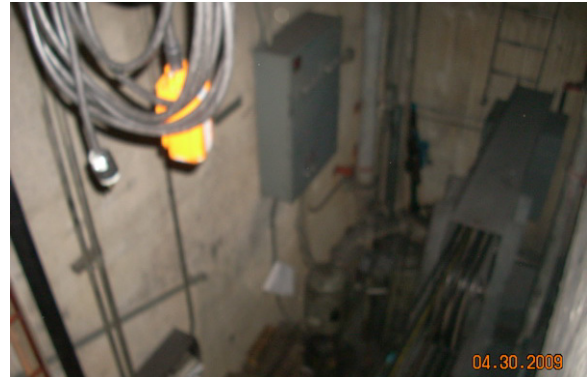
The existing plumbing system serving the Arch and lower tram load zones is limited to the sump pumps located at the lower tram load zones. These existing sump pumps serve to remove groundwater, which seeps up from the lower tram load zones due to the high water table at the Arch site (Figure 255). Close inspection of these sump pumps was not possible at the time of the field investigation. The existing sump pumps are column type pumps, with motors mounted above the sump basin and the pump assembly located in the sump basin. It is unknown as to whether or not the current sump pumps are original to the construction of the Arch. No archival documentation has been found to confirm replacement of these sump pumps. Park maintenance staff has indicated that the sump pumps have been rebuilt in the past, and that the pump motors have been replaced within the last five years.

The sump pumps are in good condition, having been recently rebuilt. No operational deficiencies were observed during the investigation or reported by park maintenance staff.

Figure 255. Arch leg sump pumps. Source: Alvine, 2008.

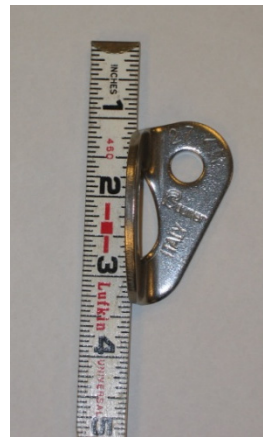
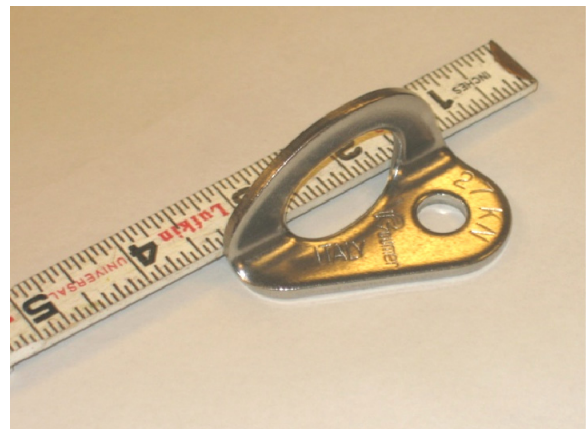
Improper introduction of these anchors can create new sites with lower corrosion resistance and thus jeopardize the exterior's longevity. However, using matching stainless steel, good welding practice, and thorough post-welding cleaning will minimize potential for corrosion at these points.

One initial solution would be to install small stainless steel anchor clips to allow limited access to some faces containing discoloration and distress (Figures 256 and 257). The use of

stainless steel anchors will greatly facilitate scheduled exterior inspections.
